THE RECOVERY, RECONSTRUCTION, AND ANALYSIS OF YENİKAPI 14 (YK
14), A MIDDLE BYZANTINE MERCHANT SHIP FROM THE THEODOSIAN
HARBOR EXCAVATIONS AT YENİKAPI, ISTANBUL

A Dissertation

MICHAEL RICE JONES

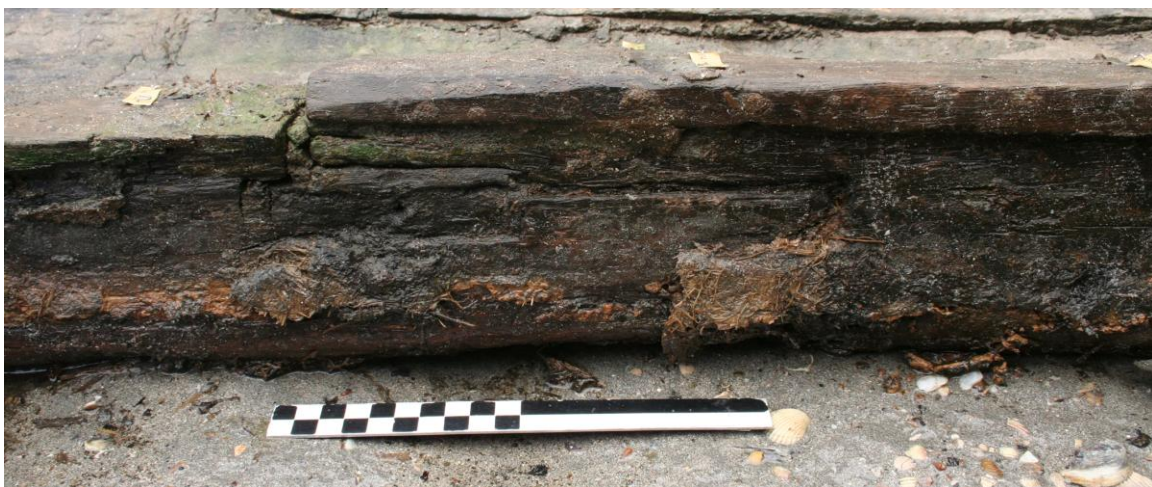
Figure 3.42: Thick pitch and caulking on the port face of the Keel 1/2 scarf.

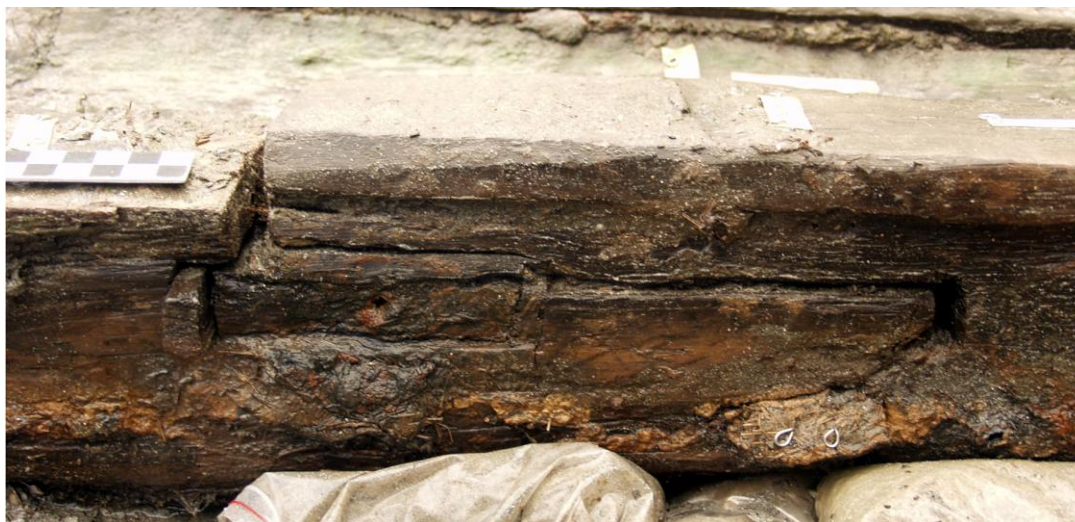
Figure 3.43: The Keel 1/ Keel 2 scarf, with the forward key partly removed.

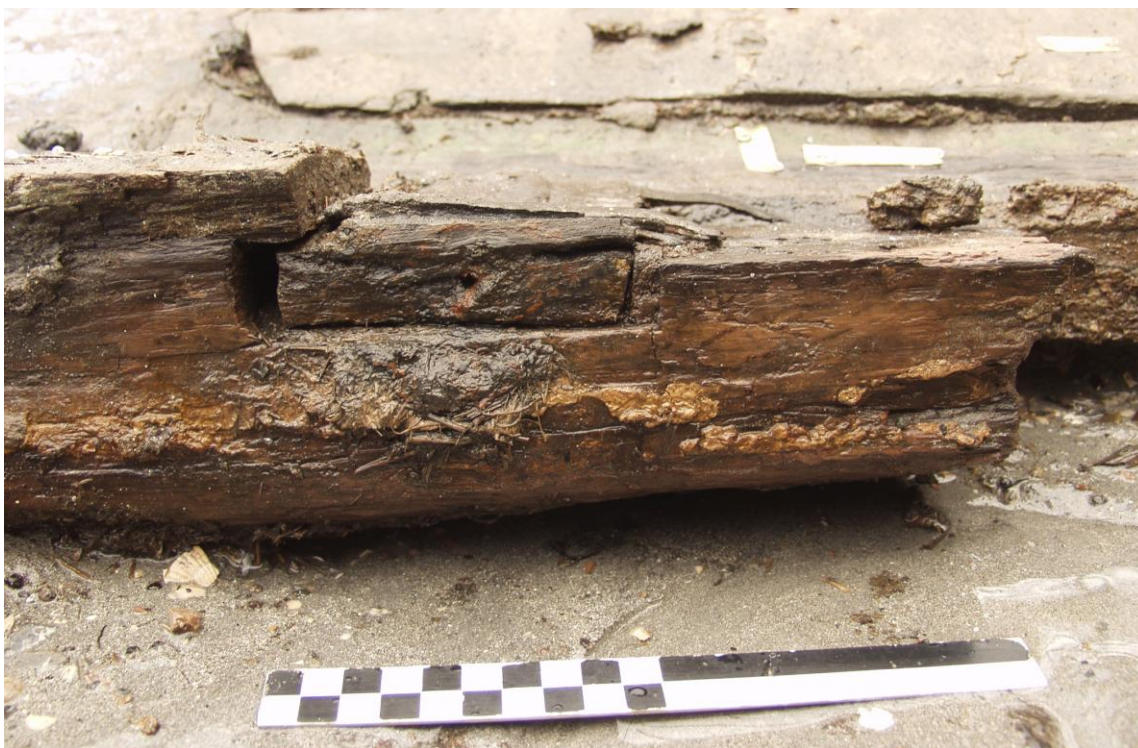
Figure 3.45: The broken section of the Keel 2 scarf. The split was found full of sand, and appears to have broken in antiquity.

Part of the forward scarf of Keel 1 was broken in antiquity, either before or, more likely, during the sinking of the ship (since there is no indication of caulking or repairing the split): the split was found filled with sand, indicating that it was an old break. The Keel 2 scarf end was also somewhat compressed by hogging, which seems to have affected the aft section of Keel 2 overall (**Figure 3.49**). This may have caused or contributed to the break in Keel 1.

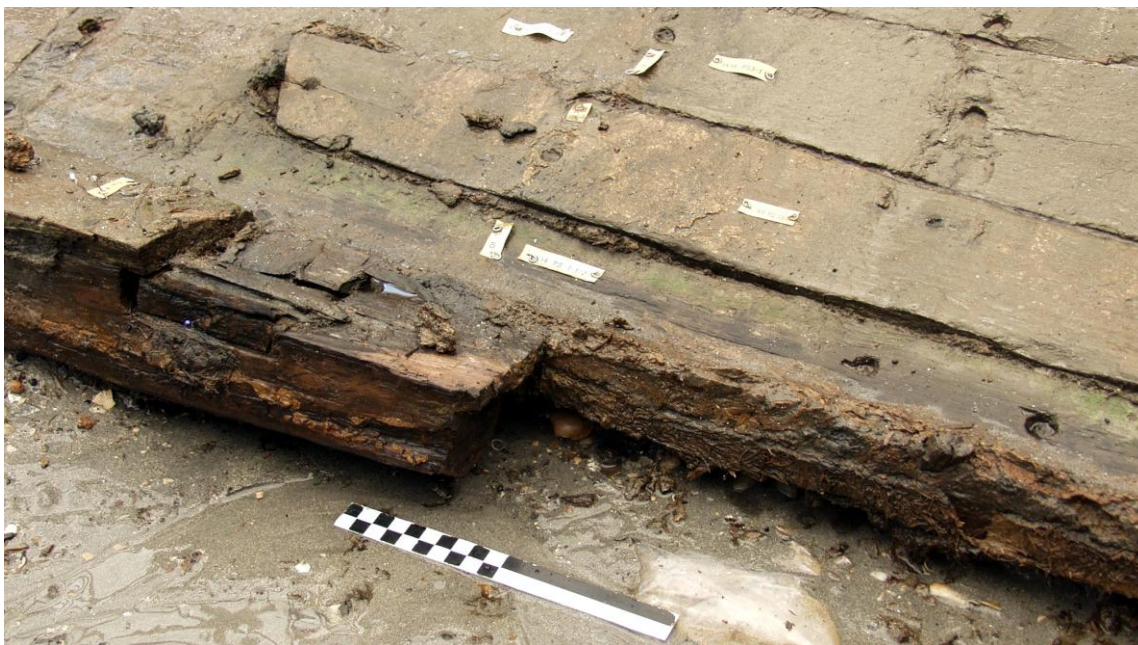
Figure 3.46: The aft scarf of Keel 2 after the removing the garboards and Keel 1 timber. Note the thick caulking and heavy pitch deposits on the keel/SS1 plank seam.

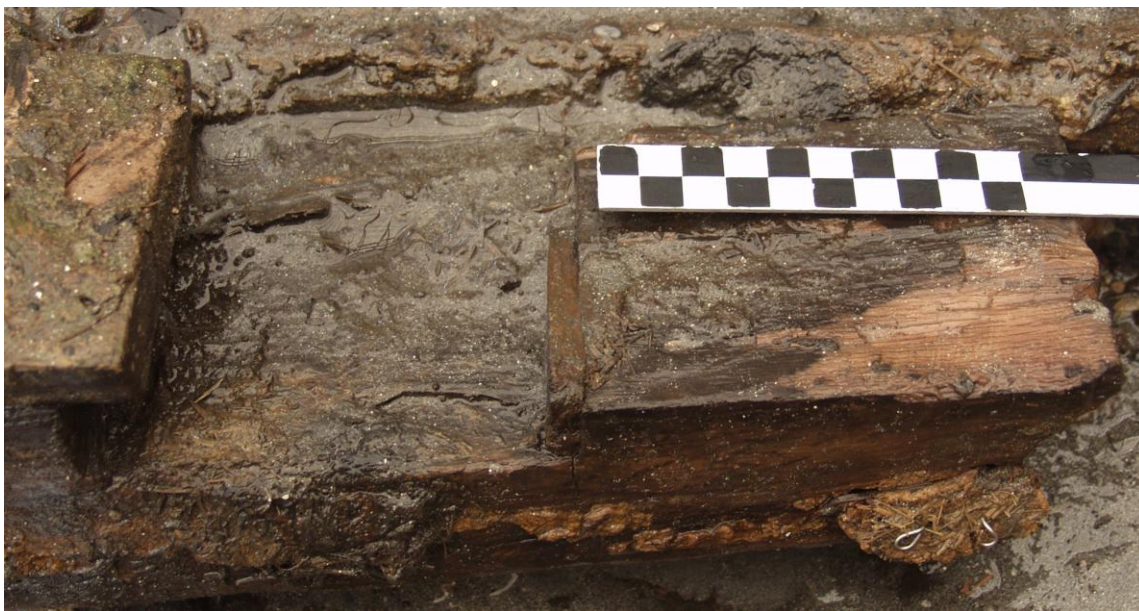
Figure 3.47: View of the middle scarf key in the Keel 1/Keel 2 scarf in situ, after the removal of Keel 1.

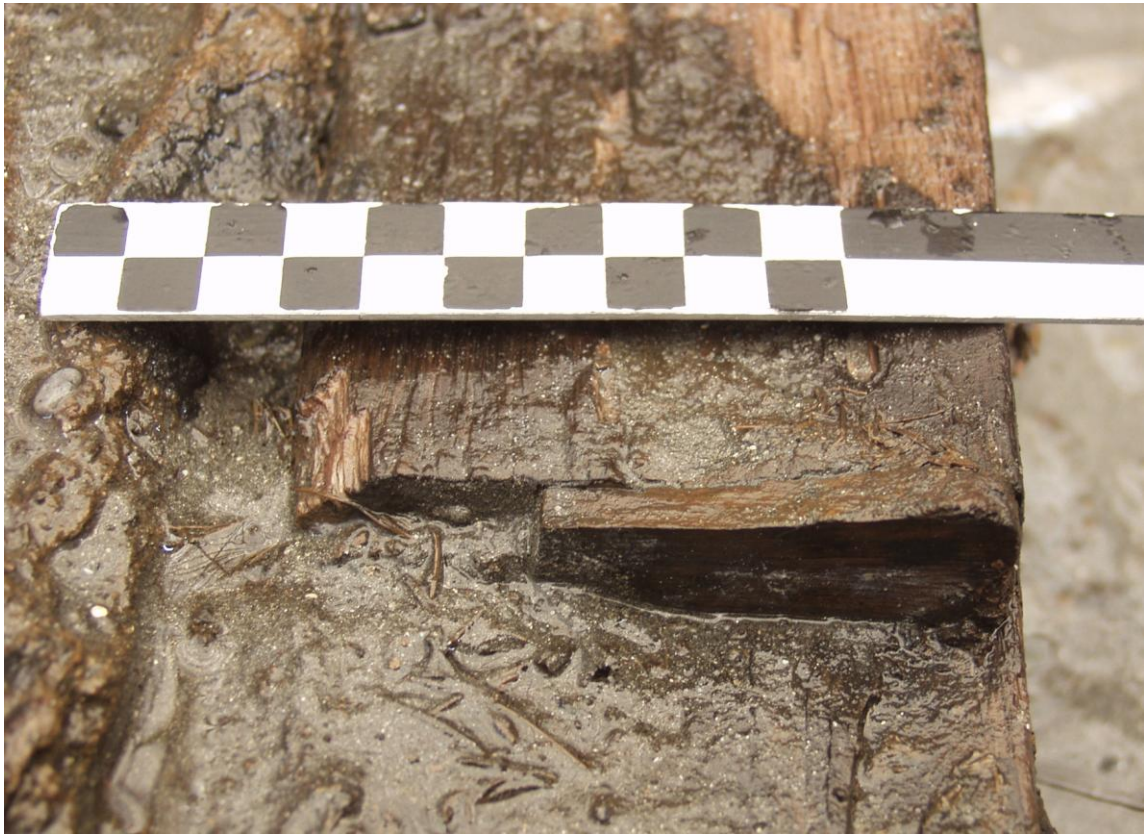
Figure 3.48: The middle scarf key of the Keel 1/Keel 2 hook scarf in situ.

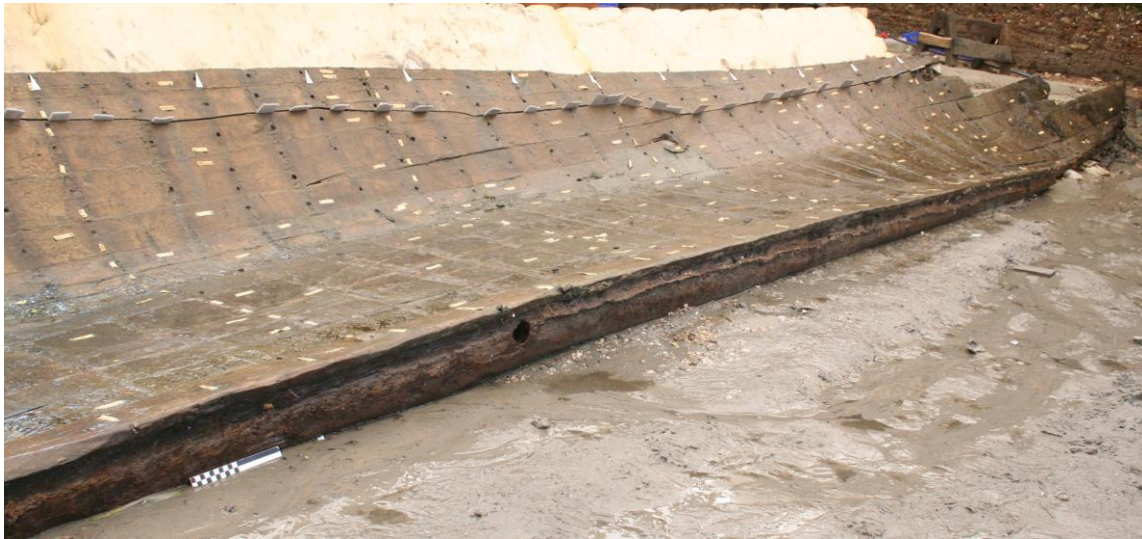
Figure 3.49: Port face of Keel 2's port face during excavation, after removing the frames and strakes SS 1 through SS 7. Note the slight hogging in the shape of the keel.

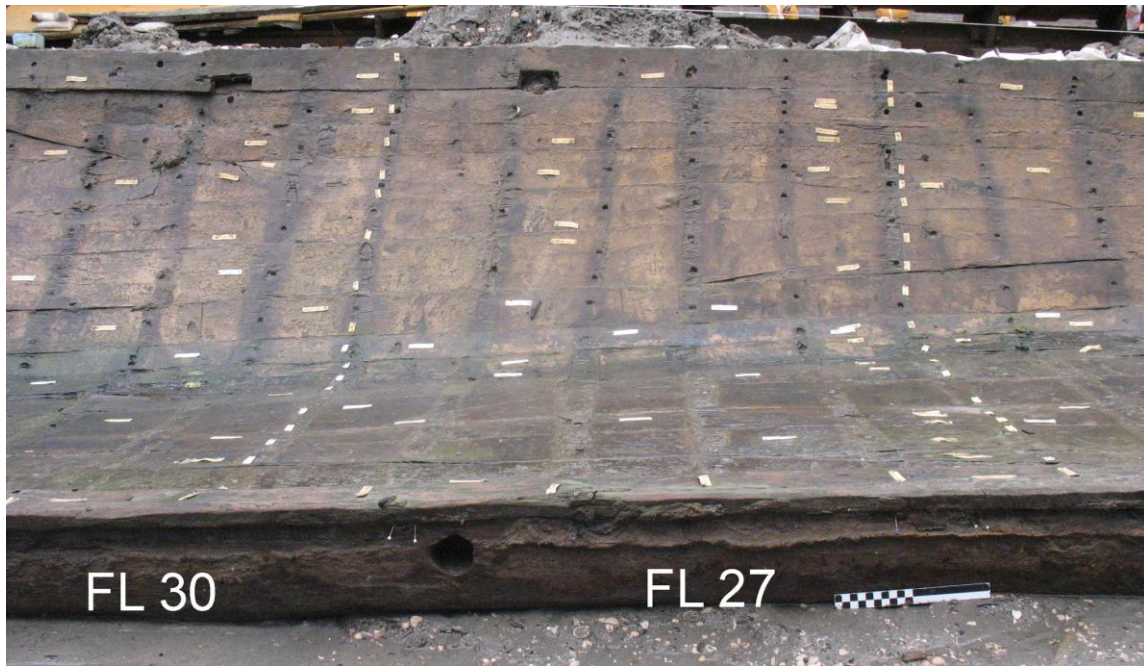
Figure 3.50: The central transverse hole in Keel 2, shown after the removal of strakes SS 1-SS 7.

Two transverse holes were cut through the port and starboard faces of the keel timbers below the garboard strakes. The aft hole was cut through Keel 2 between FL 28 and 29 and measures 4.6 to 4.8 cm in diameter on its starboard face and 5.0 to 5.2 cm in diameter on its port side (**Figures 3.50-1**). A second transverse hole was cut through Keel 3 between FL 40 and 41, measuring 4.9 x 4.0 cm in diameter on the starboard (Keel/PS1) side and 5.2 x 3.7 cm on the port (Keel/SS1) side of the timber (**Figures 3.52-3**). Both holes are worn around their forward edges; at the aft hole in Keel 2, this area of wear is approximately 1.3 cm wide on the port side and 2.0 cm wide on the starboard side, while on the forward hole on Keel 3 it is approximately 2.1 cm on the port and starboard sides. The insides of both holes are worn smooth, and no tool marks survive, but they were likely made by a combination of drilling and chiseling.

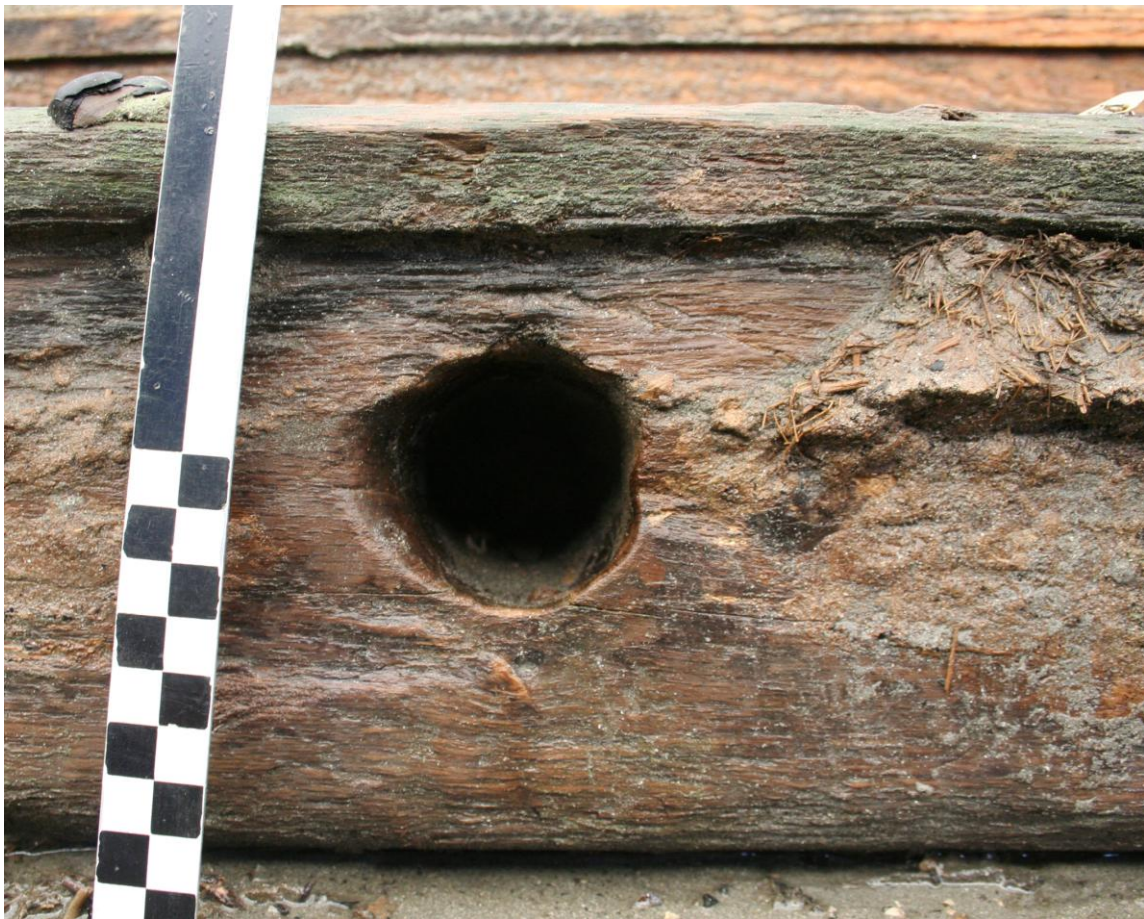
Figure 3.51: Port face view of the hole in Keel 2 between FL 29-30. Note the wear to the left (forward) side of the hole.

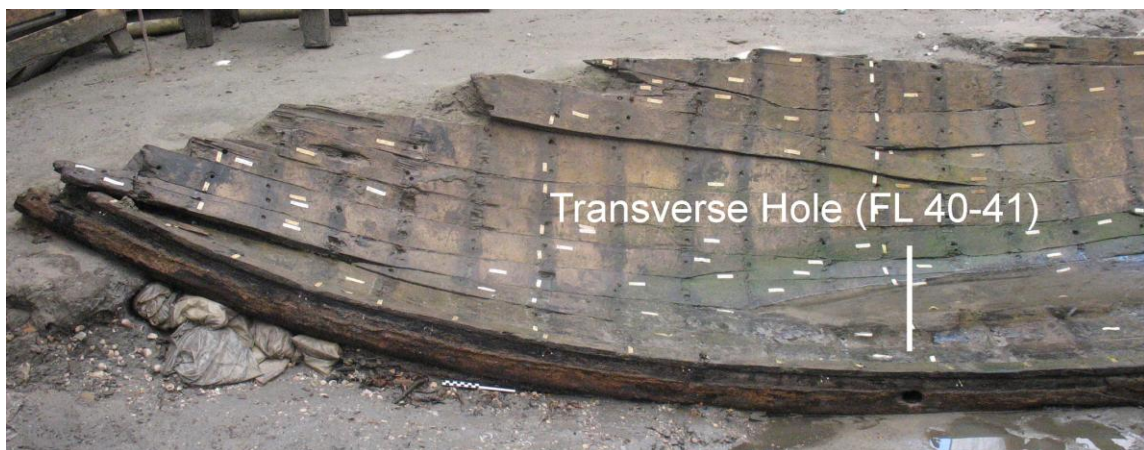
Figure 3.52: The forward transverse hole in Keel 3, between FL 40-41.

The reason for these holes is unclear, but they were most likely cut for running cables through the keel to assist in towing or beaching the vessel. Similar transverse holes have been found on the keel and endpost timbers on many of the shipwrecks at Yenikapı.³¹¹

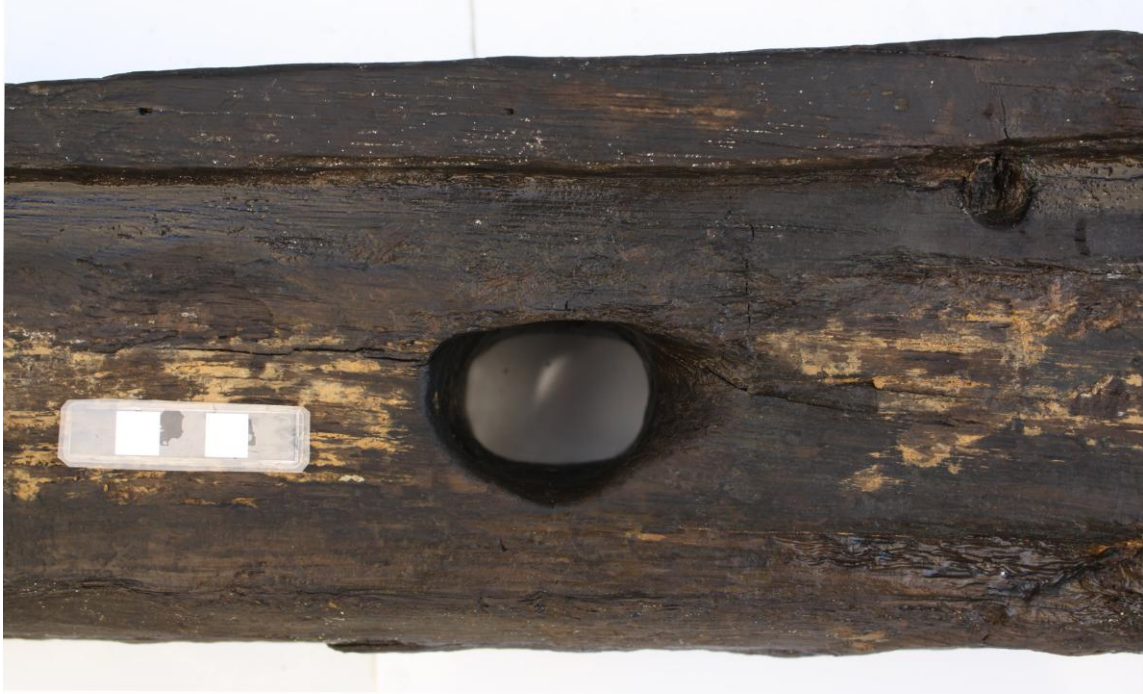
Figure 3.53: Detail of the transverse hole in Keel 3. The detail view shows the starboard face of the hole: the forward end is to the right.

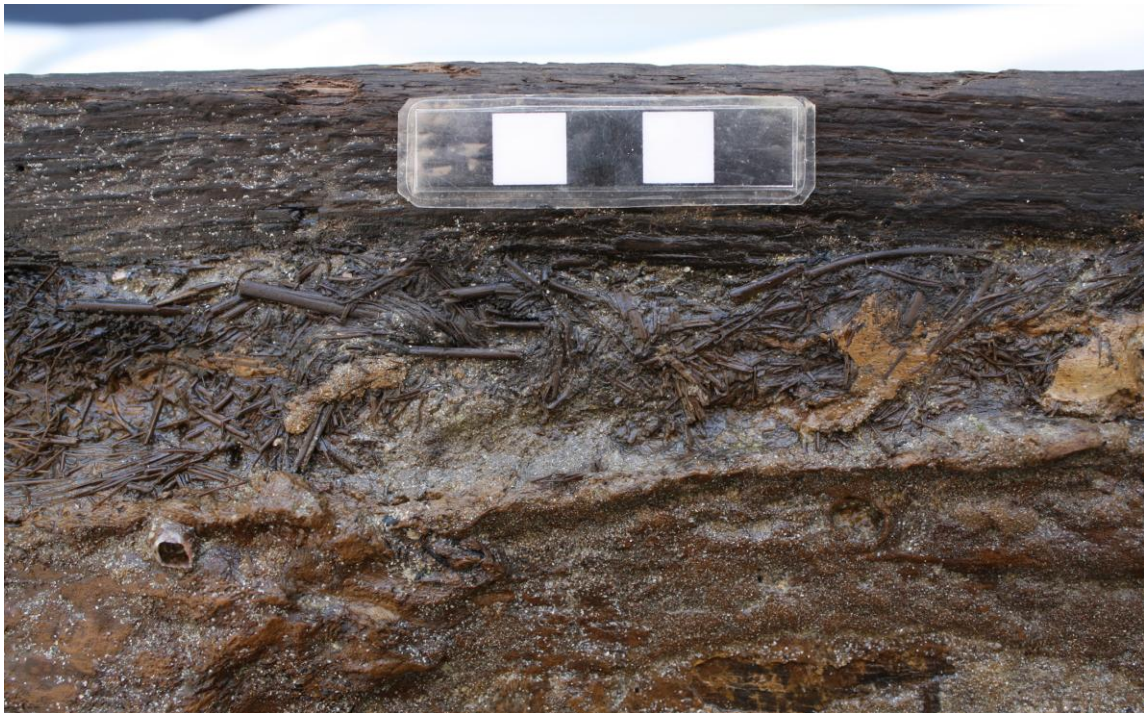
Figure 3.54: Detail view of a keel/garboard seam caulking on the port face of Keel 2. Note the barnacle to the lower left.

At a few locations on the keel/garboard seam that were probably re-caulked, deposits of up to 2.0 cm thick were removed.³¹⁴ Barnacles 0.7 to 1.4 cm in diameter were found in the pitch layer on the port and starboard faces of the keel, some partly obscured by pitch; possibly these shells were covered in later applications of pitch during hull maintenance episodes.³¹⁵ Rough grooves or gouges were found on the port and starboard faces of the keel in the area of the keel/garboard seam, underneath thick caulking and pitch deposits in most areas (**Figures 3.55-6**). These measured 0.4 to 1.3 cm wide and were generally 0.1 to 0.4 cm deep; they were filled with pitch, and grass fibers were found to be driven deep into the cuts in many areas. These grooves or gouges were probably caused by caulking irons, either during the initial construction of the ship or, more likely, during a later episode of re-caulking or maintenance of the hull. In most areas, the grooves were concealed under caulking and pitch, and wood splinters protruding from the hull were embedded in the pitch. These grooves were found on both faces at the locations described in Table 3.4.

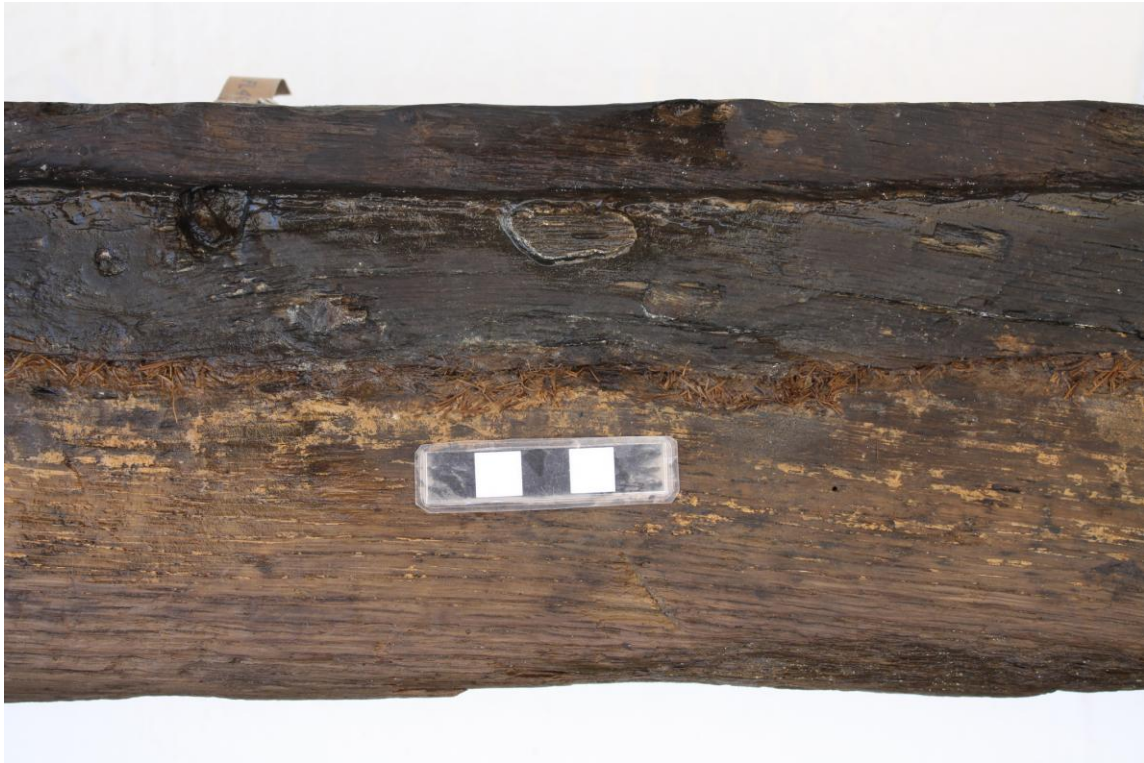
Figure 3.55: A roughly-chiseled groove was found on the port face of Keel 3 under the caulking and pitch layer. The groove is at the approximate location of the bearding line, and was found full of caulking and pitch; this damage was likely caused by re-caulking of the keel/garboard seam.

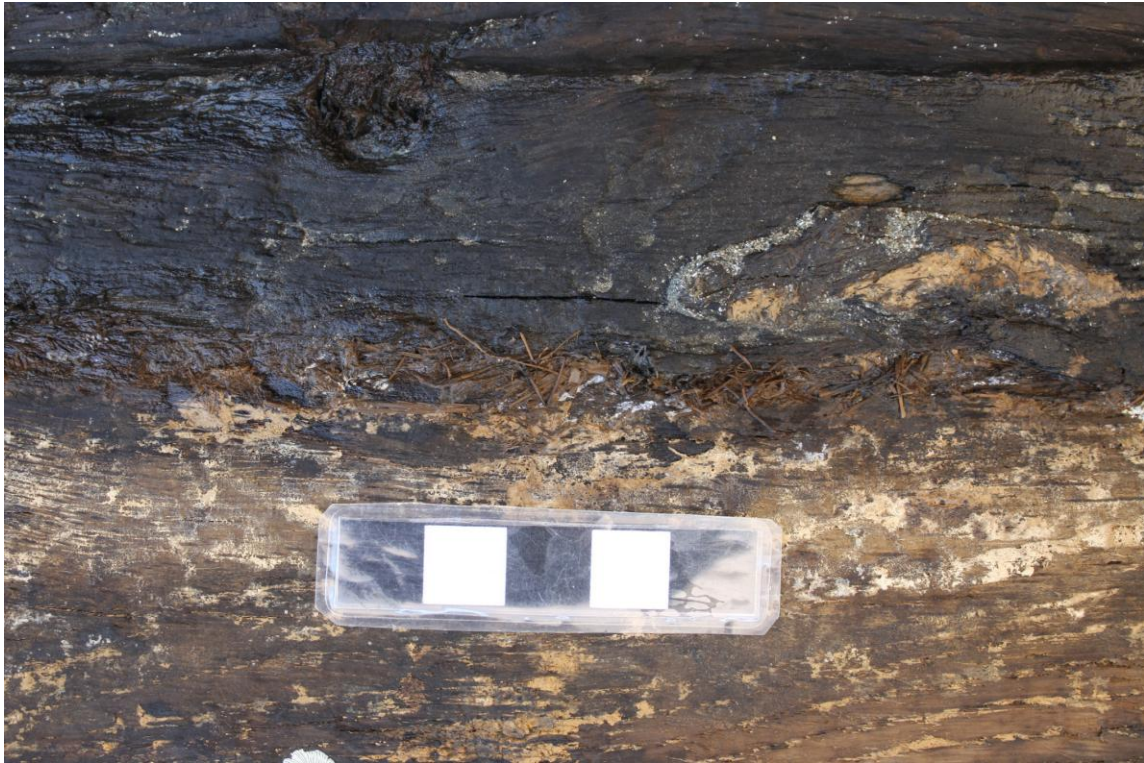
Figure 3.56: Detail of one of the gouged areas in the keel; Keel 3, port face (Keel/SS 1 plank seam). Note the caulking fibers forced into the gouged depression.

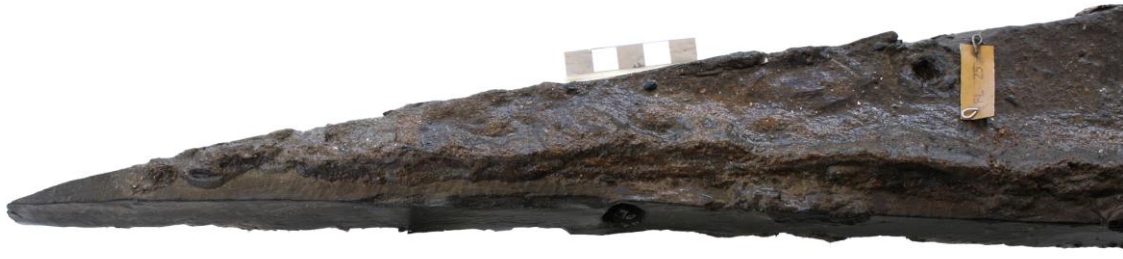
Figure 3.57: Pitch ridge on the aft scarf of garboard plank SS 1-2.

Pitch was also heavily applied to the keel/garboard plank seams inside the hull, in the gap above the keel rabbets and the inner faces of the garboard strakes (**Figure 3.57**).

These deposits ranged in width from 1 to 3 cm, although in some areas under floors they filled larger gaps, from 0.3 to 1.7 cm in depth. Judging from the thick pitch deposits applied to the keel/garboard seams inside the hull, these deposits have two possible causes. During the application of pitch inside the hull, it may have flowed into the keel/garboard seam, the lowest point in the hull. Because this area was also a potential source of leakage, the thickness of the pitch deposits could have also been deliberate.

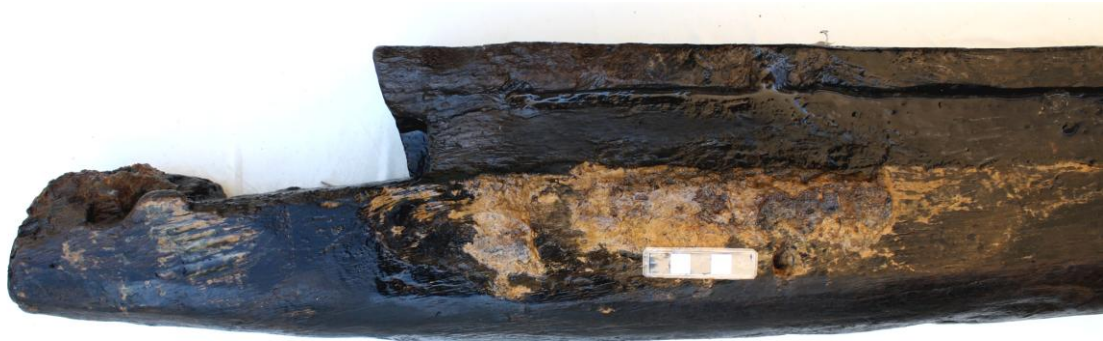
Figure 3.58: Drilled hole in the port face of Keel 3, in the approximate location of floor FL 50 (next to scale), below the garboard's original position.

In addition to the coaks connecting the keel and garboard strakes, three fastener holes below the garboard strakes were found in the keel timbers. A drilled hole 1.2 cm in diameter and approximately 1-2 cm deep was found in Keel 3's port face in the area of FL 50, just above the beginning of the outer face bevel; the hole was found filled with pitch and caulking (**Figure 3.58**). A second drilled hole was found on the port side, just above the outer face bevel, below the location of FL 38, on the opposite end of Keel 3. The hole is 1.1 cm in diameter and contains a nail concretion 0.6 cm square in cross section and up to 7.2 cm long (**Figure 3.59**). Both fastener holes are possible evidence for temporary attachments of stocks or braces to the keel timbers during construction.

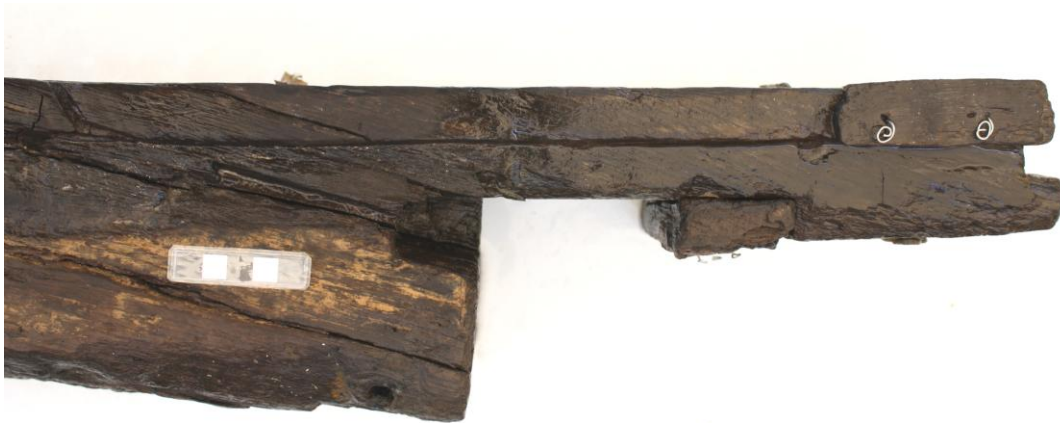
Figure 3.59: Keel 3's aft scarf, port face view. Note the nail hole near the outer face edge just aft of the beginning of the scarf (FL 37-38 area).

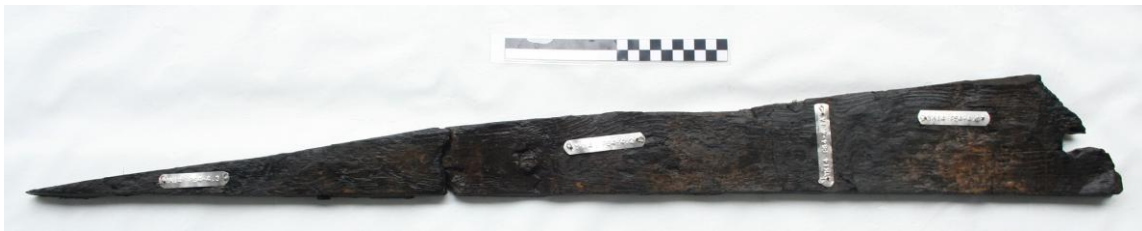
Figure 3.64: PS 4-4, a tapered plank whose forward end (left) was likely trimmed to a point after being edge-fastened to the hull.

planks tended to be used at the turn of the bilge or towards the ends of the hull (in particular, in strakes PS 6-8 and SS 6-7), where several served as stealers or drop strakes (e.g., PS 10A, 10B, and 12A), while the largest, widest planks were used in the relatively flat bottom of the hull before the turn of the bilge (including strakes PS 1-4 and SS 1-4). As with most shell-built ships, there is a clear attempt to shape symmetrical runs of planking in the first few strakes used in the hull. These are very similar in length and shape, although four shorter pieces were used in strake SS 1 and only two were used in PS 1, perhaps due to a lack of larger planks during construction.³²⁰ After strake 3, the hull planking became more irregular, as shorter pieces were used in strakes SS 4 and 5, while longer, more regular pieces appear to have been used in strakes PS 4 and PS 5. Some planks terminating in the area of the turn of the bilge may have been trimmed down. This would likely explain the thin, tapered forward ends of SS 3-2, PS 4-4, and the forward end of PS 5, which were fastened to the previous strake with unusually short coaks (**Figure 3.64**).

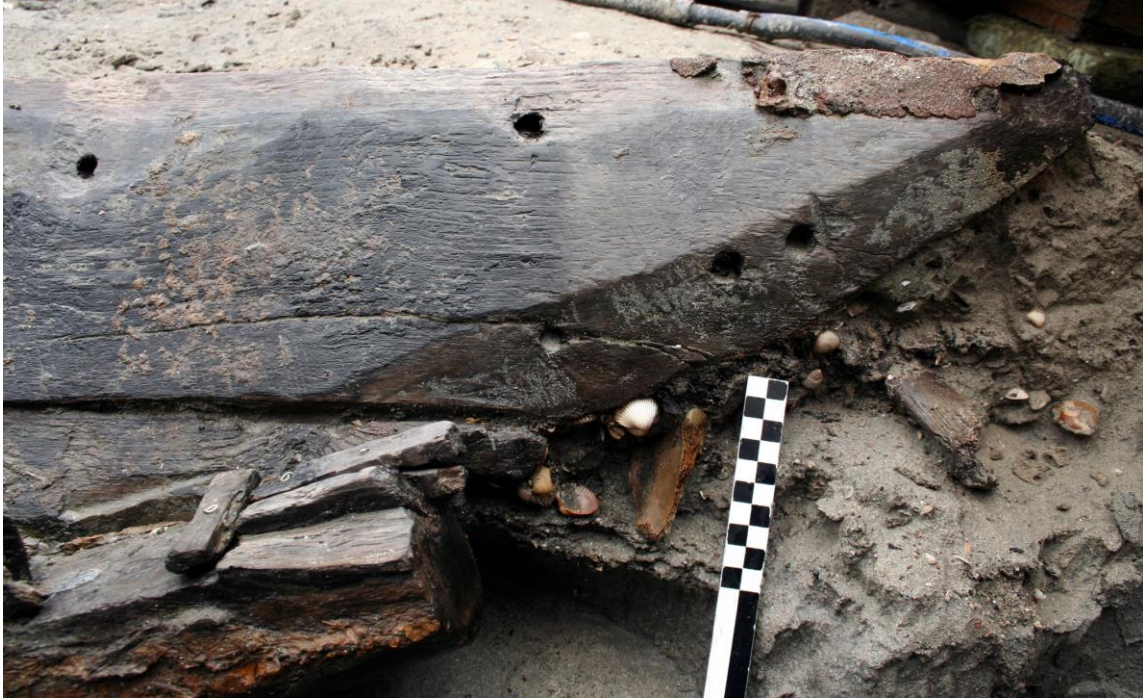
Figure 3.65: The aft-hood end of PS 3-1 in situ.

The six garboard planks from the ship were recovered complete; they consist of two planks on the starboard side (PS 1-1 and PS 1-2) and four planks on the port side (SS 1-1/1, SS 1-1/1A-5, SS 1-2, and SS 1-3). The garboards' keel edges are beveled to fit snugly into the keel rabbet, with sharper bevels and hood ends occurring towards the ends of the hull, up to 1.7 cm wide on the starboard (Keel/PS 1) side and 3.8 cm wide on the port (Keel/SS1) side. Hood ends of strakes above the garboards were cut wider, up to 4.8 cm wide on SS 3-1 and PS 3-1 (**Figure 3.65**).

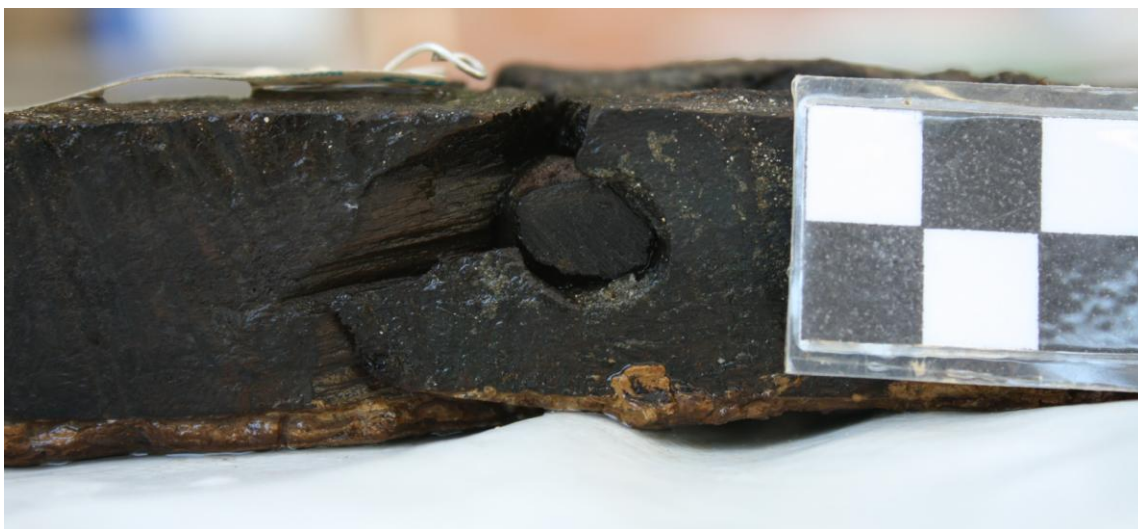
Figure 3.67: Detail of a coak on the after-diagonal scarf of PS 10-2, which had been cut and caulked over.

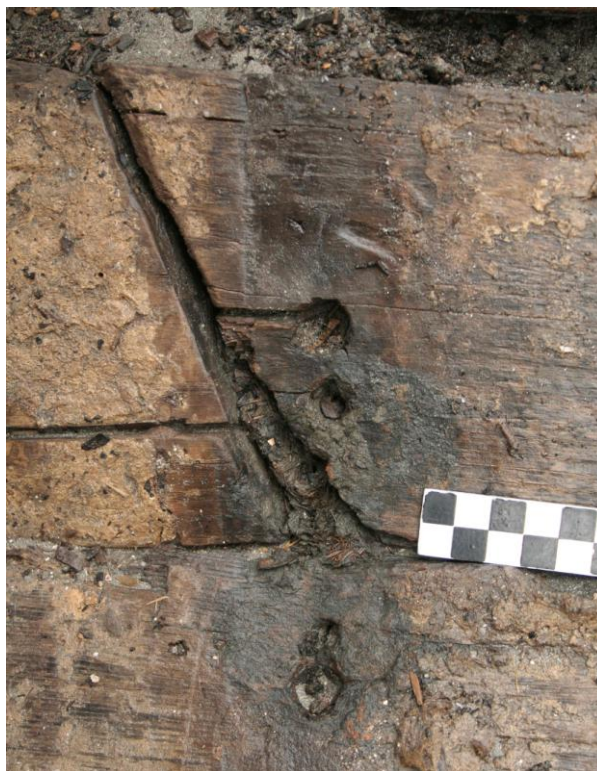
Figure 3.68: The plank scarf between SS 6-2A, a repair plank (at left), and SS 6-3, an original plank, before dismantling. Note the thick caulking in the scarf seam.

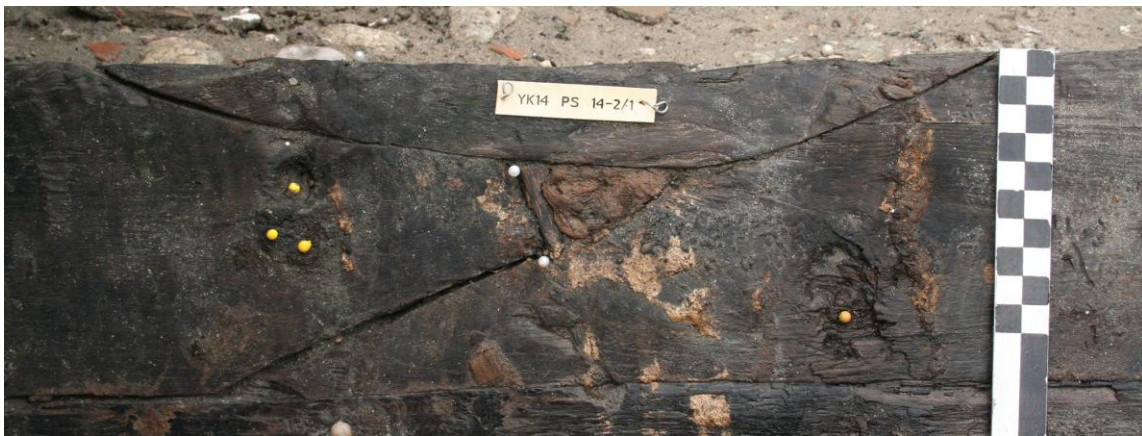
Figure 3.70: The scarf between PS 14-1 (right), 14-2/1 (center, labeled), and PS 14-2/2-6 (left), before dismantling.

The scarf between planks PS 14-1, PS 14-2/1, and PS 14-2/2-6 is a unique type (**Figures 3.70-2**). Although the forward end of PS 14-1 and the aft end of PS 14-2/2-6 resemble a typical diagonal or ‘S’ scarf end, a crescent-shaped piece, PS 14-2/1, was inserted in the scarf’s outboard edge; all three pieces were fastened with coaks that were used only to fasten the planks to each other and not to the wale timber below. A small triangular gap was situated in the center of the scarf, with an exposed coak protruding at the edge of PS 14-2/2-6, perhaps the reason for the loss of the scarf tip. This gap was filled with a plug made of a mixture of hair and pitch, approximately 5.2 x 2.5 cm on its inner face and 6.9 x 3.0 cm on its outer face. The plug itself is 3.3 cm thick, about 1 cm thicker than the surrounding planking; most of the plug’s excess thickness bulged from the plank’s outer face. This unusual configuration is probably a repair to the planking that occurred during the construction of the hull; the tip of the diagonal or S-scarf being cut for PS 14-2/2-6

probably broke off when the shipwright drilled coak holes to edge-fasten the two scarf ends or when coaks were driven to fasten the scarf. The scarf ends on both planks were cut down and a third piece, PS 14-2/1, was inserted in the gap and fastened to the other two with coaks. The forward-most coak hole is particularly unusual in that a small wooden plug, 0.9 cm long and 1.1 cm in diameter, was inserted into the lower edge of the coak hole in PS 14-2/2-6 to block the remaining, unfilled section of the hole.

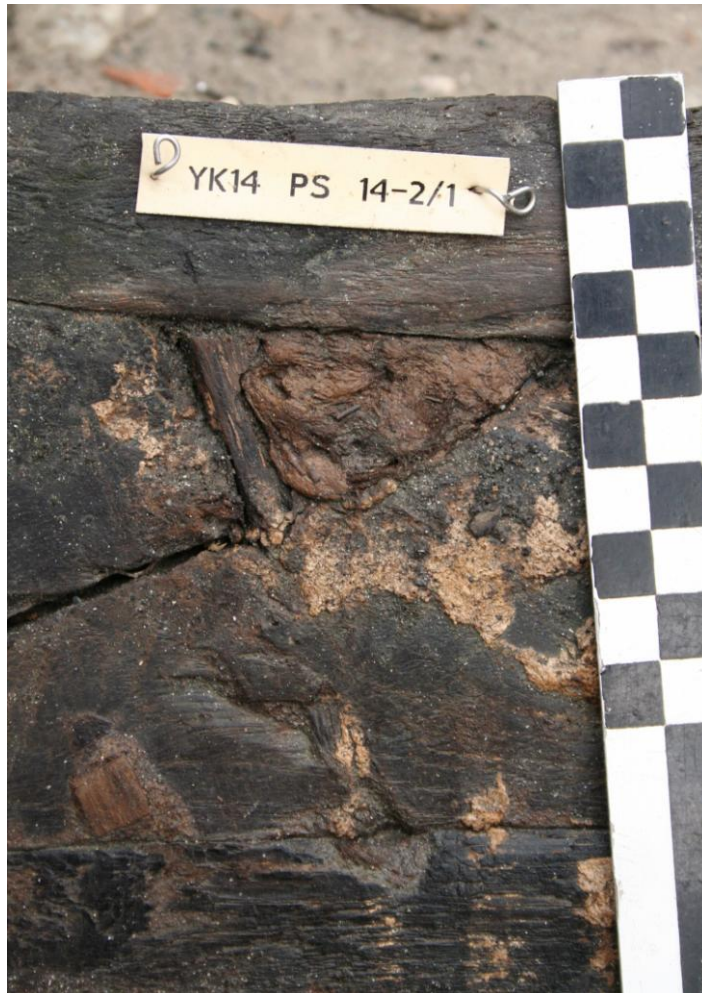
Figure 3.71: Detail of the caulking plug of hair and pitch at the PS 14-1/PS 14-2 scarf.

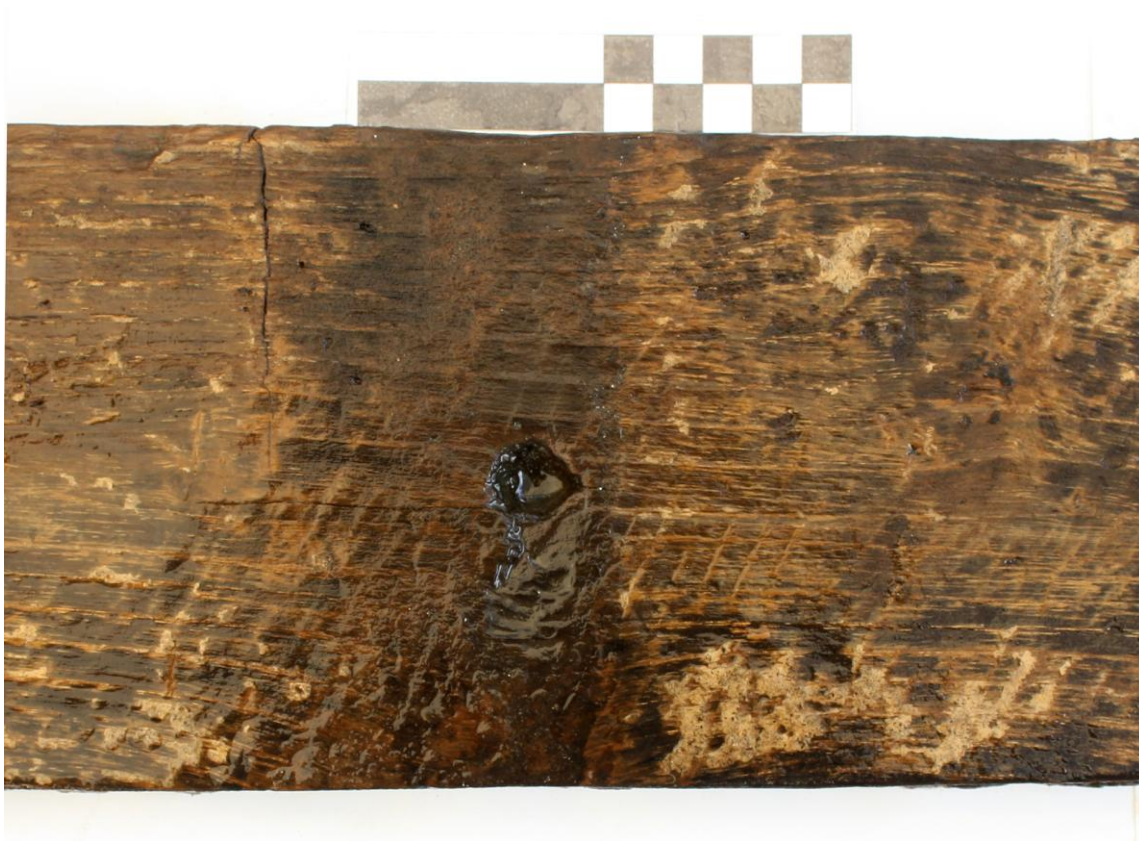
Figure 3.73: Saw marks on the inner face of plank PS 9-3. Note the saw marks' relatively wide spacing and uniform orientation of the marks; these features were typical on hull planks that were not dubbed with adzes.

Saw marks on most of the hull planks are usually fairly widely spaced (0.3-0.5 cm or more) and tend to run in relatively uniform directions, except at occasional features such as knots, which were more difficult to cut (**Figure 3.73**). Saw marks on some of the garboard planks, particularly SS 1-2 and SS 1-3, were more closely spaced and run in several directions in some areas. Arc-shaped marks are apparent on SS 1-2's aft scarf; these may be 'saw return marks' caused by pulling the saw back in a curved motion, similar to tool marks described on one of the floor timbers from the Serçe Limanı ship.³²⁶

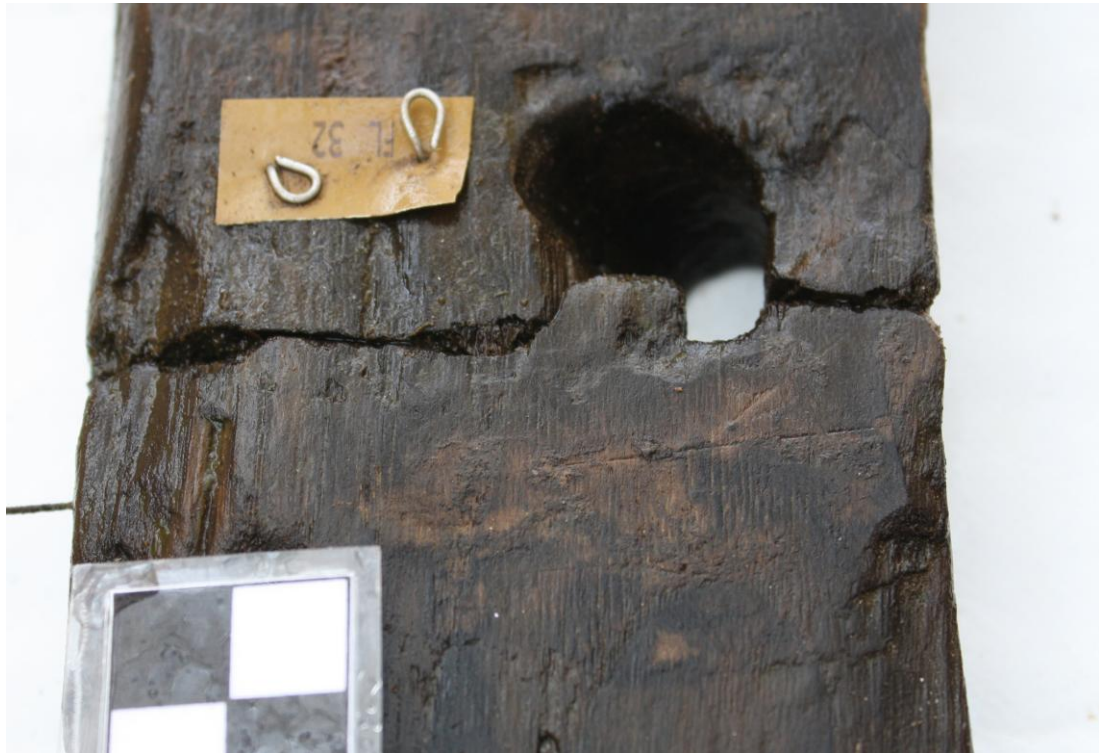
Figure 3.74: Score mark at the location of one edge of FL 32, on the inner face of plank SS 7-2.

hull planking is the presence of score marks at the edges of frame locations, sometimes covered by a layer of pitch (**Figure 3.74-5**). These are most frequently found at the turn of the bilge on either side of the hull, in areas that may have been less susceptible to wear or further dubbing with adzes. Similar score marks may have existed in other areas along proposed frame edges but could have been adzed away later as both the planking and floor timbers were trimmed to fit flush with each other.³²⁷ Many more score marks were found at the locations of coaks.³²⁸

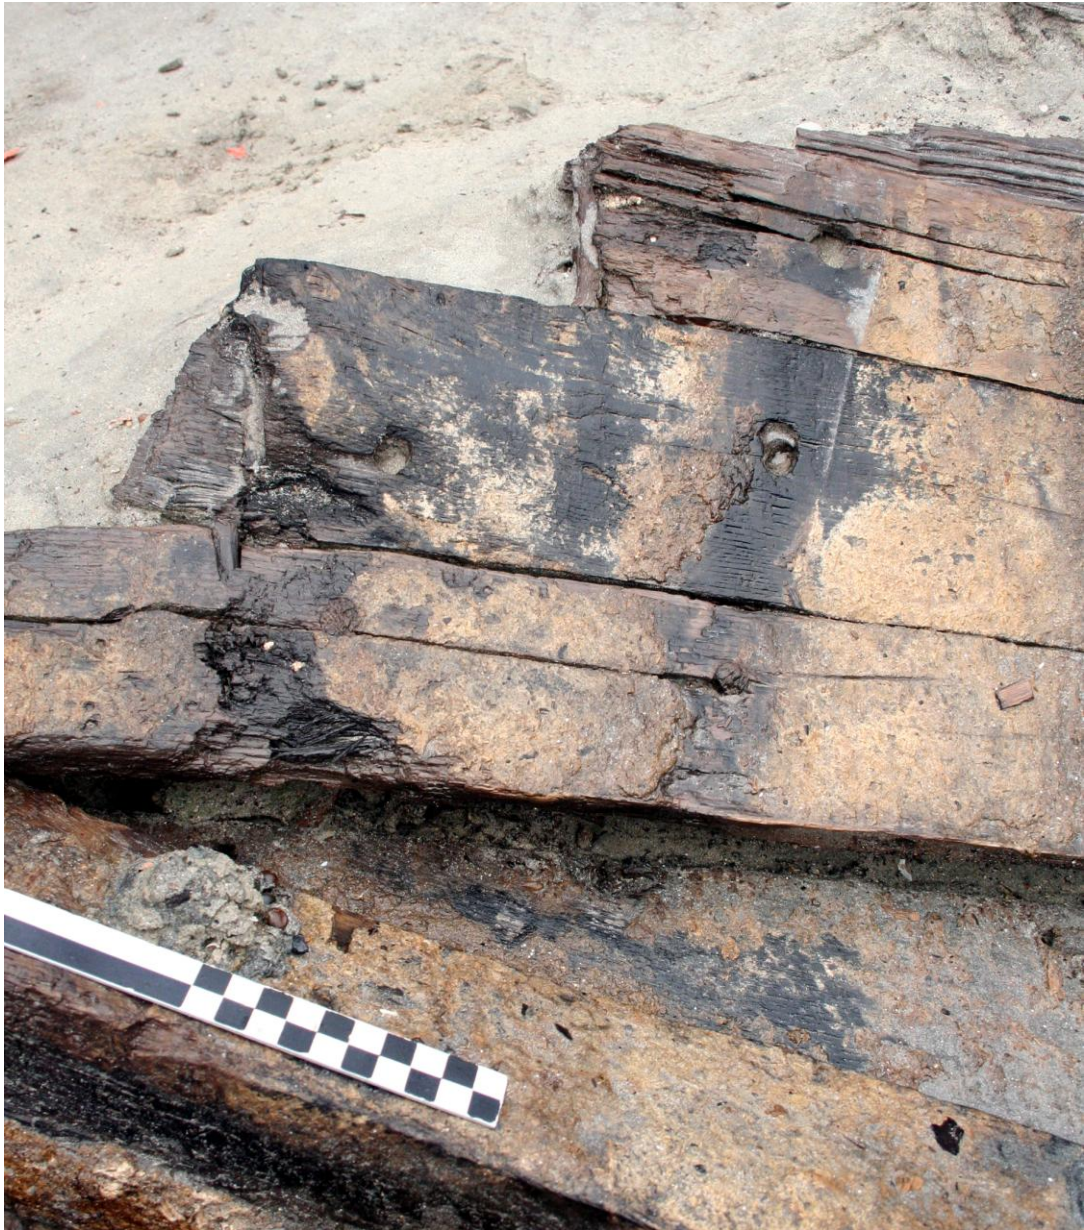
Figure 3.75: Example of charring on the inner faces of hull planks at the bow (PS 1-2, 6-3, 7-3, and 8-3).

deal of experience to perform correctly and involves propping the plank over a fire for periods of up to several hours, while keeping the upper side wet (**Figure 3.75**).³²⁹

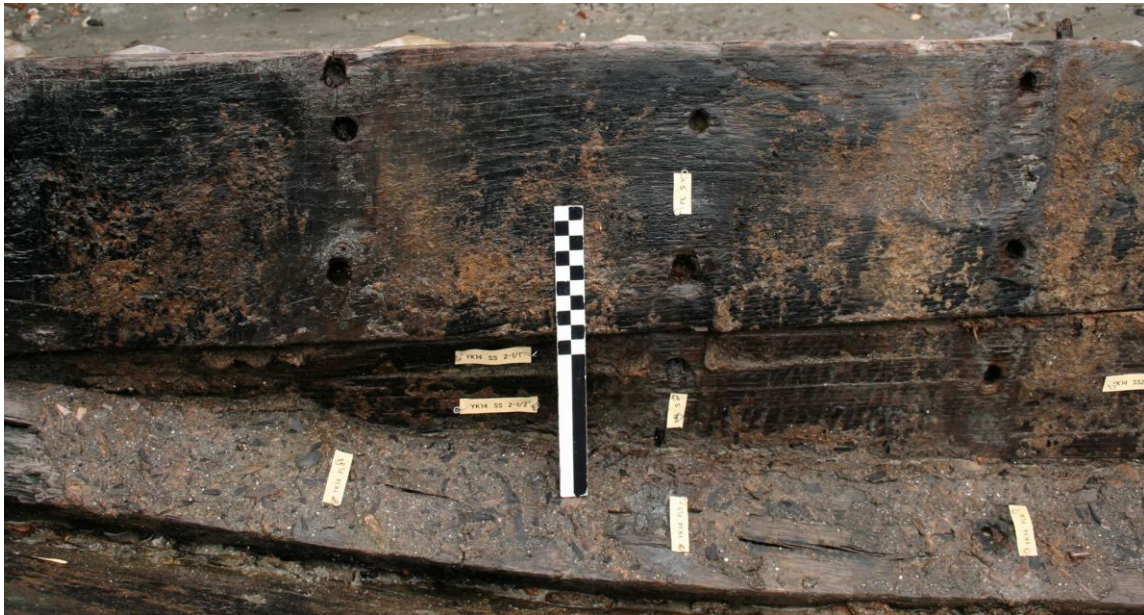
Figure 3.76: Strakes SS 2 and SS 3 at the aft end of the hull. Note the blackened surface on SS 3 (the upper plank in the photo), compared to the lower plank, SS 2; this is due to charring of the plank in order to bend the plank for fastening to the endpost.
